September 17, 2018

Re: condition of Ludlow Forest after successive gypsy moth defoliations and potential response

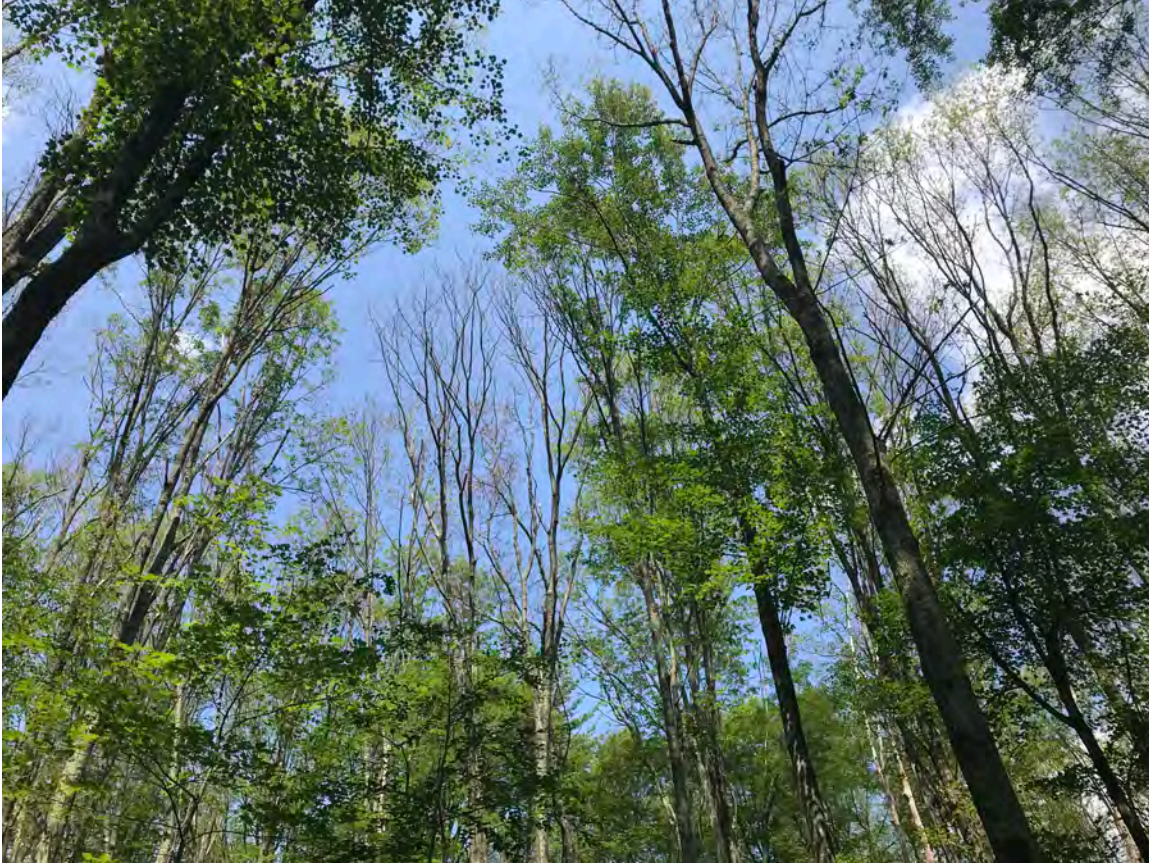
Picture 1: General view of the canopy showing severe defoliation typical at this time (pic 8-8-2018), as seen from the paved path. Normally at this time of year, the canopy would be dark with foliage. Instead, there are significant gaps. The gaps are oak trees with little or no foliage. Most green foliage is on other hardwoods (hickory, maple, ash, cherry), and on white pine and hemlock.

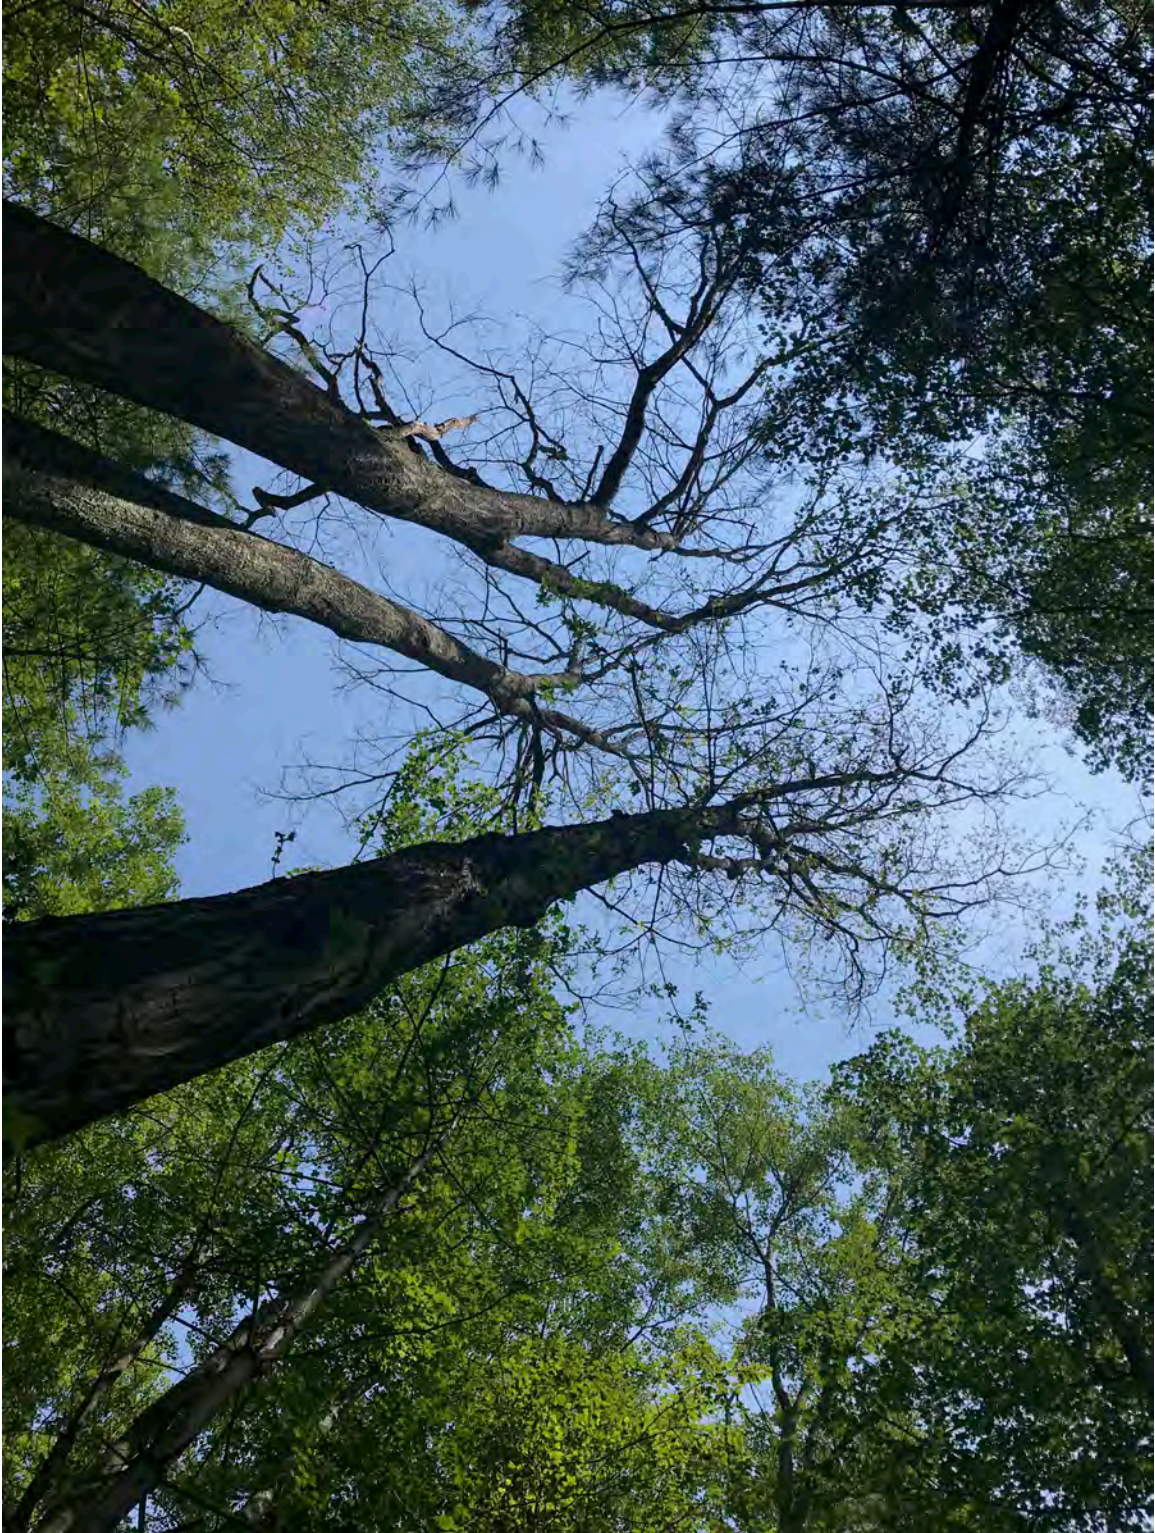
Picture 2: View up at defoliated oaks surrounded by red maple and other hardwoods, as seen in the forest interior. Despite having a few leaves and technically still alive, these oaks are unlikely to leaf out again next year. In effect, trees such as this are all but dead.

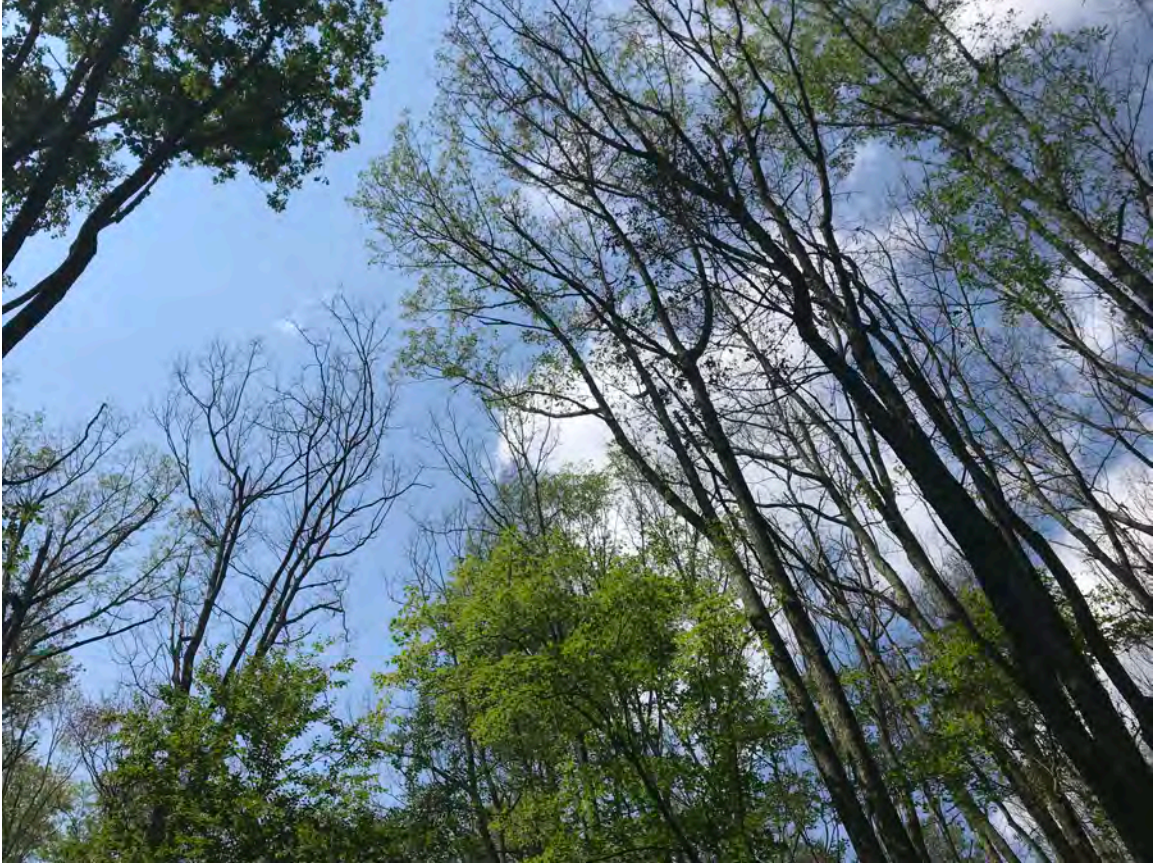
Picture 3: Typical view of a concentrated area of defoliated oaks as seen from the paved path, August 8, 2018. The 2018 defoliation follows a severe defoliation in 2017. This consecutive defoliation has placed oaks under extreme stress. Trees with no foliage or minimal foliage at this juncture are likely to be dead or to die imminently. (Broken branches on some trees most likely stemming from the 2011 Halloween snowstorm are evident on some trees).

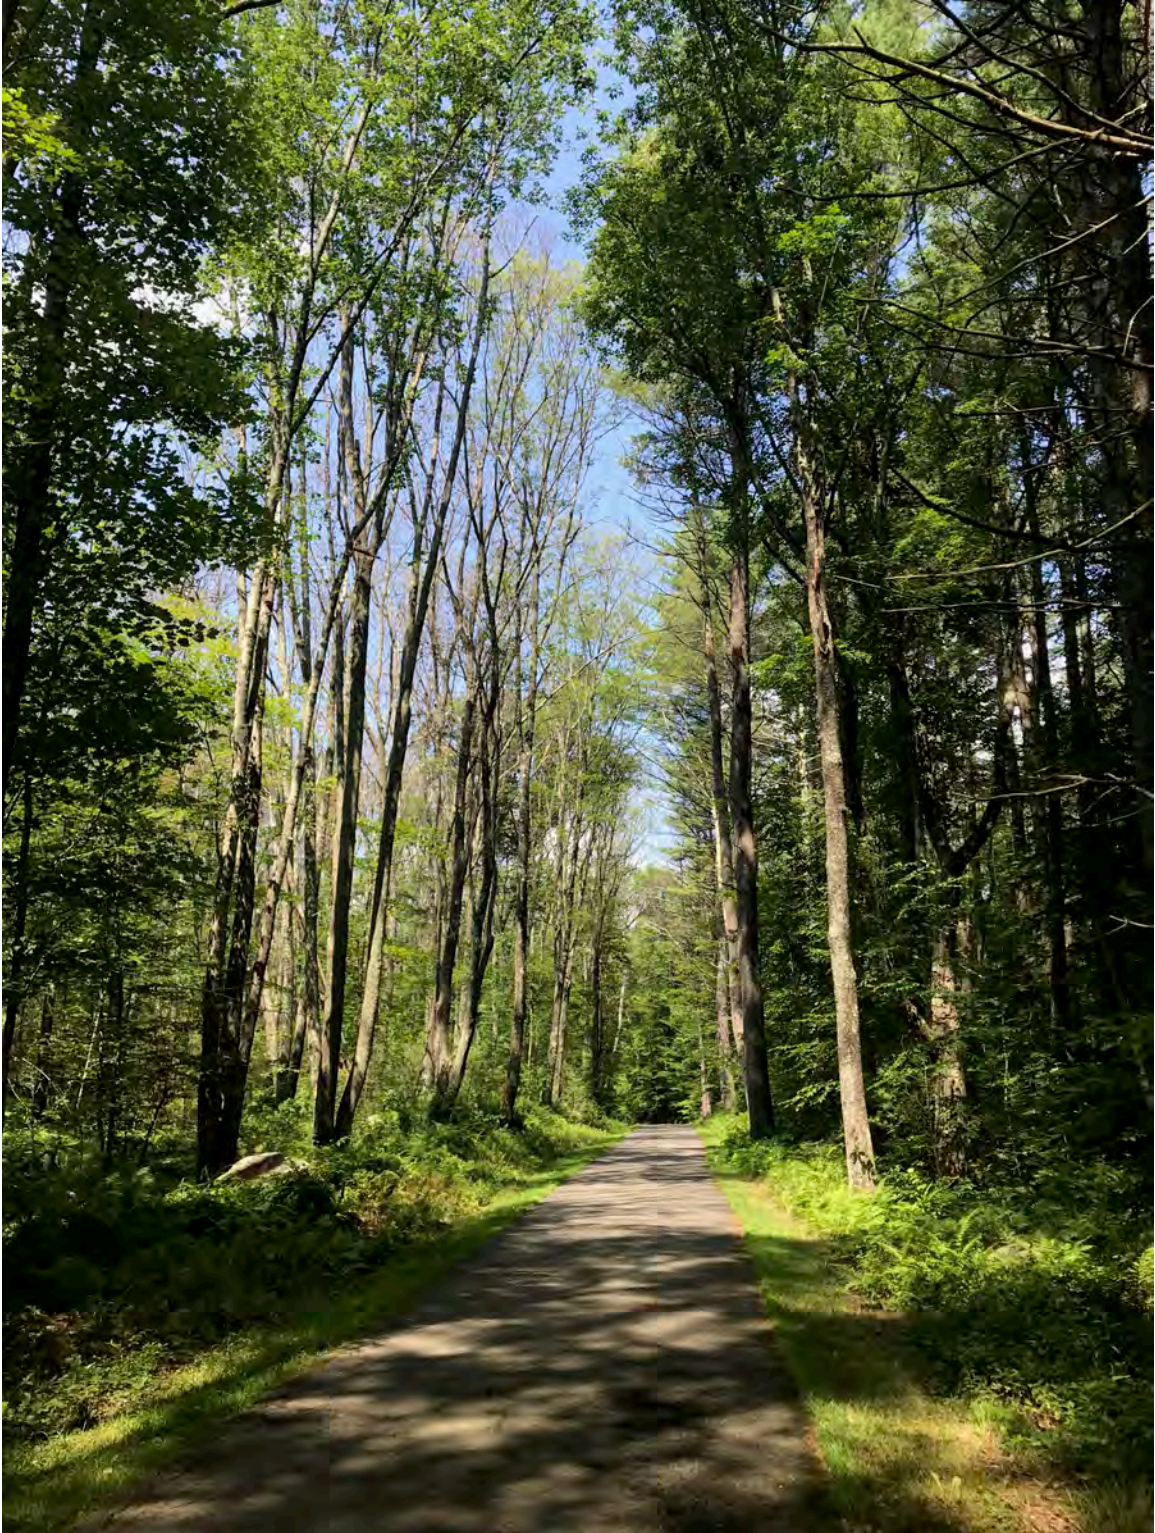
Picture 4: Concentrated area of defoliated oaks next to the paved trail/road. Most oaks observed on 8-8-2018 had little or no foliage. This was still true on 8-20-2018. Normally, the paved path would be in dense shade at this time of year.

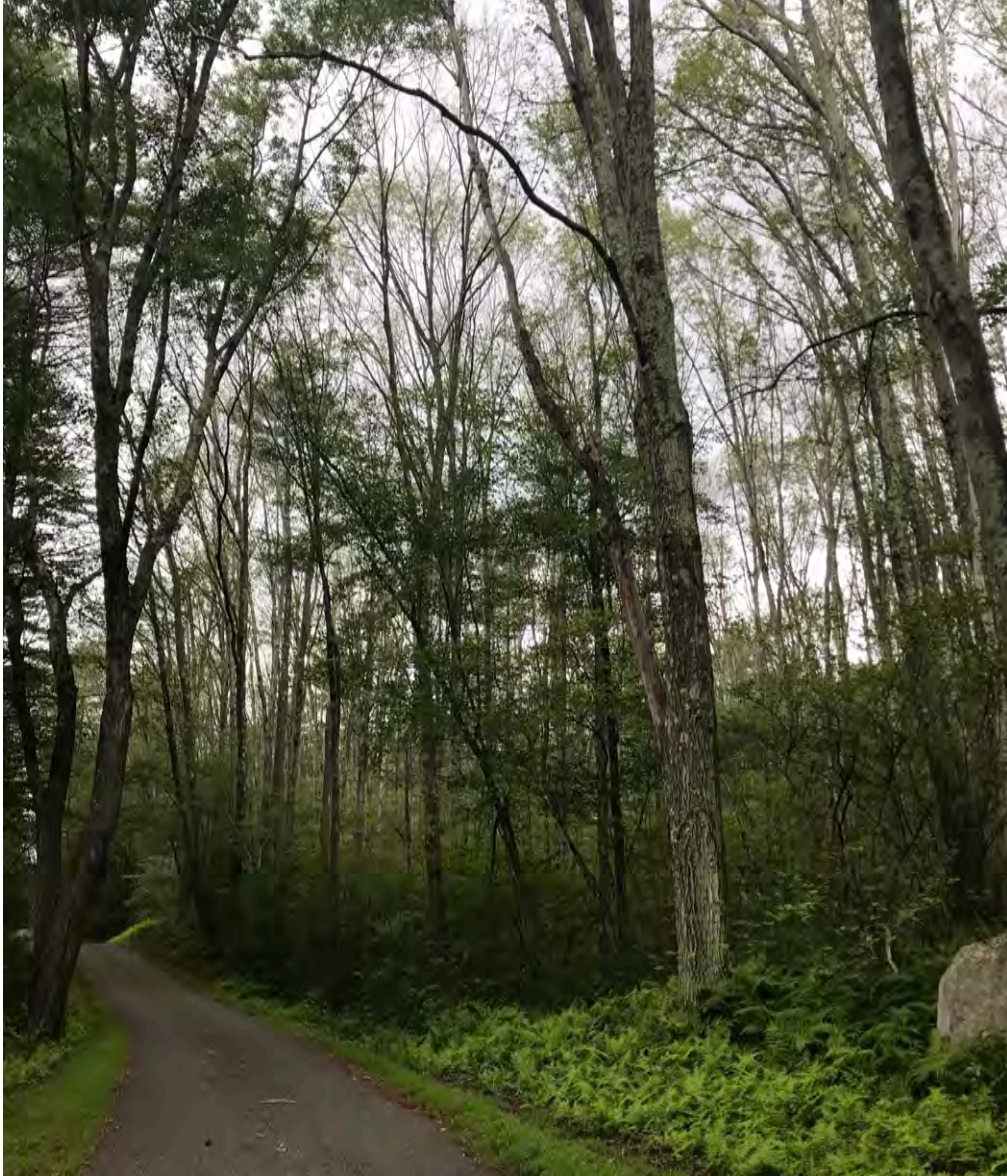
Picture 5: Another concentrated area of defoliated oaks next to the paved trail/road, as viewed on 8-20-2018. Normally, the sky would not be visible through the trees at this time of year.

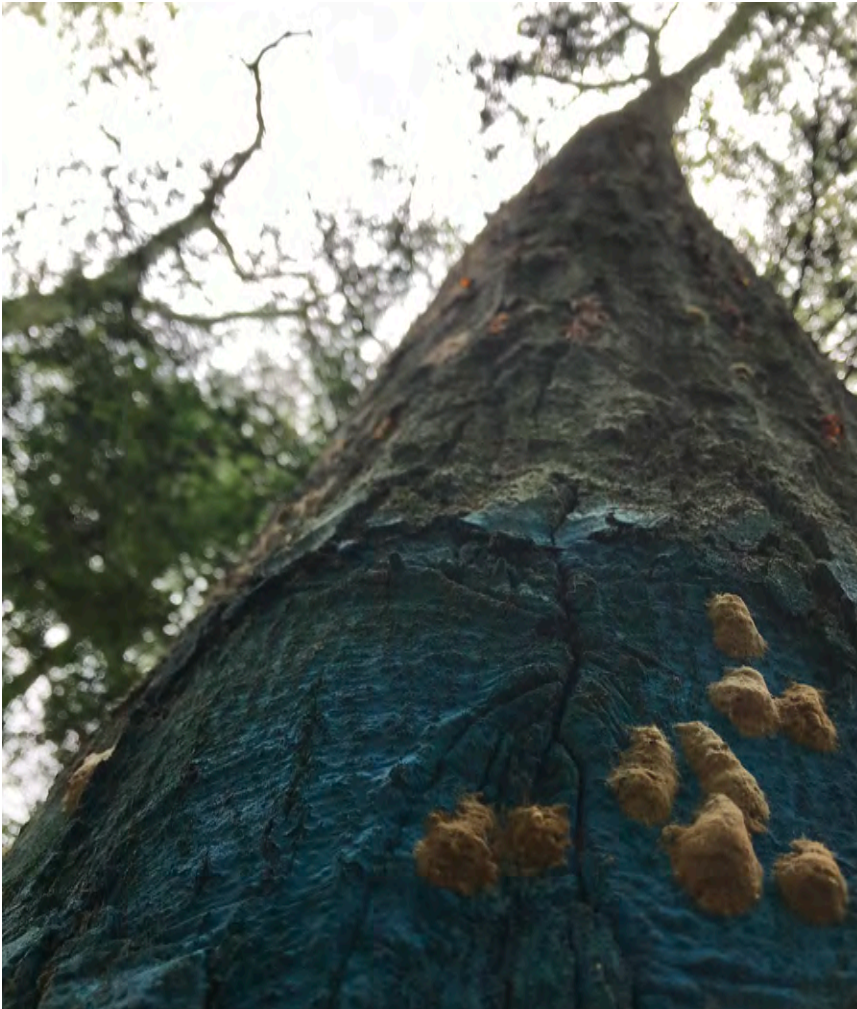
Picture 6: Gypsy moth egg cases (8-20-2018) on oak tree on SWSC property boundary (blue paint). Markings from older egg cases are visible above. The tree and its neighbor (to the left) have almost no live foliage.

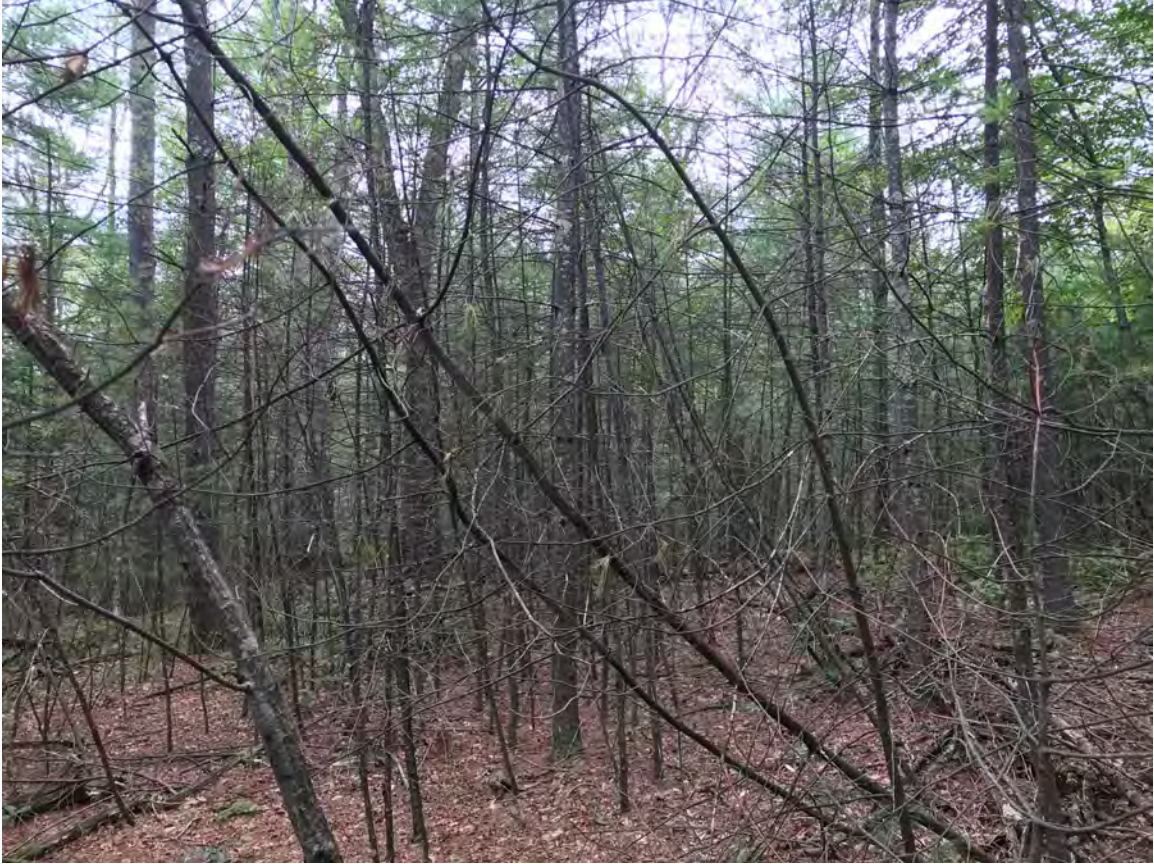
Picture 7: Concentrated area young white pine that is dead. While overstory white pine have survived recent years of defoliation by a set of needle fungi, many of the young white pine trees have succumbed to a combination of needle fungi, a stem fungus, and drought. As a result, the amount of white pine ready to be recruited into the overstory has been greatly reduced. Also, there is very little hemlock available to be recruited. The future forest is likely to be dominated by hardwoods (e.g. oaks, maples, birches, cherry, poplar). Actions that can be taken by SWSC at this time can enhance the diversity of the future hardwood mix and are discussed in the letter.

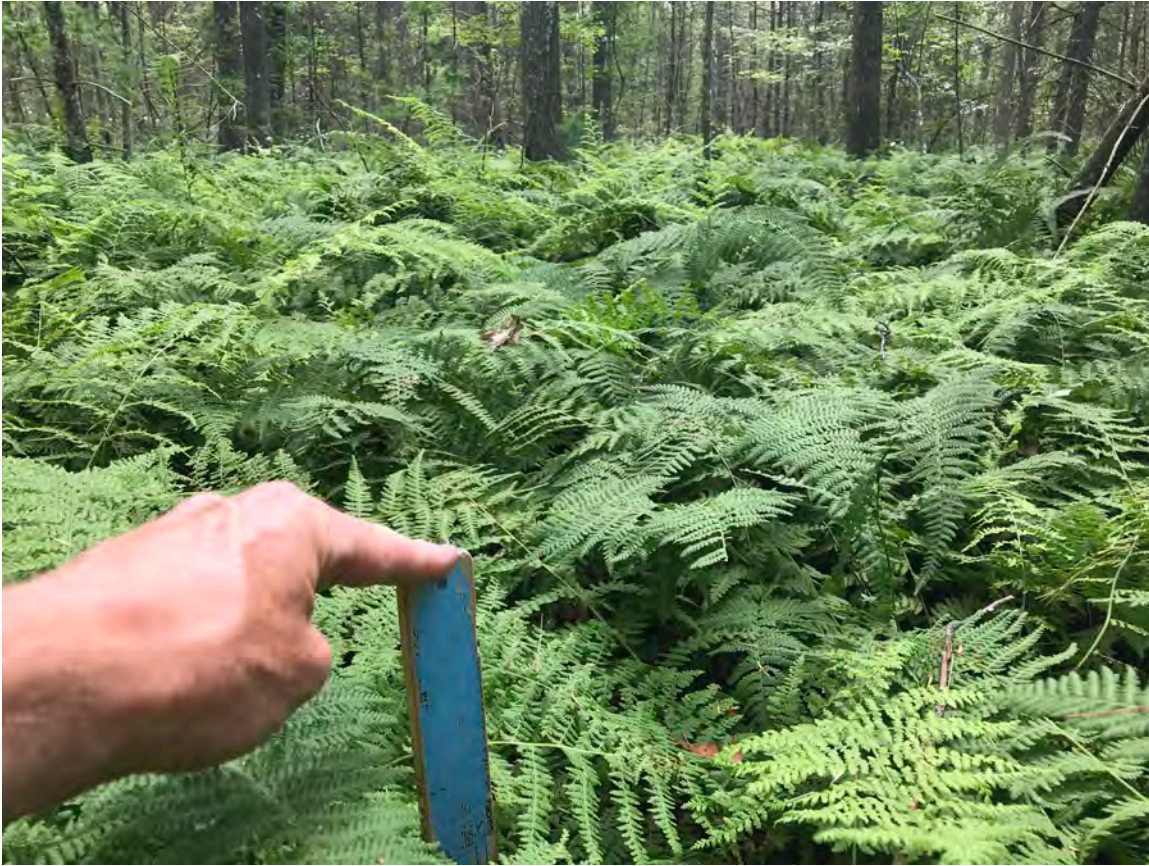
Picture 8: An example of a nearly 3'-thick layer of hayscented fern, which blankets some but not all areas of the Ludlow forest (8-20-18). Hayscented fern is a native interfering plant that can prevent the establishment and survival of tree and shrub seedlings as well as herbaceous vegetation, greatly reducing diversity. Hayscented fern seems to be thriving and spreading with the increases in filtered light caused by the gypsy moth defoliation. Heavy disturbance that causes a flush of blackberries can ultimately shade out hayscented fern and later give way to tree seedlings. If deer browse is heavy, the blackberries will be eliminated before the fern is shaded out. If all else fails, a glyphosate treatment in August is known to be very effective at killing hayscented fern.

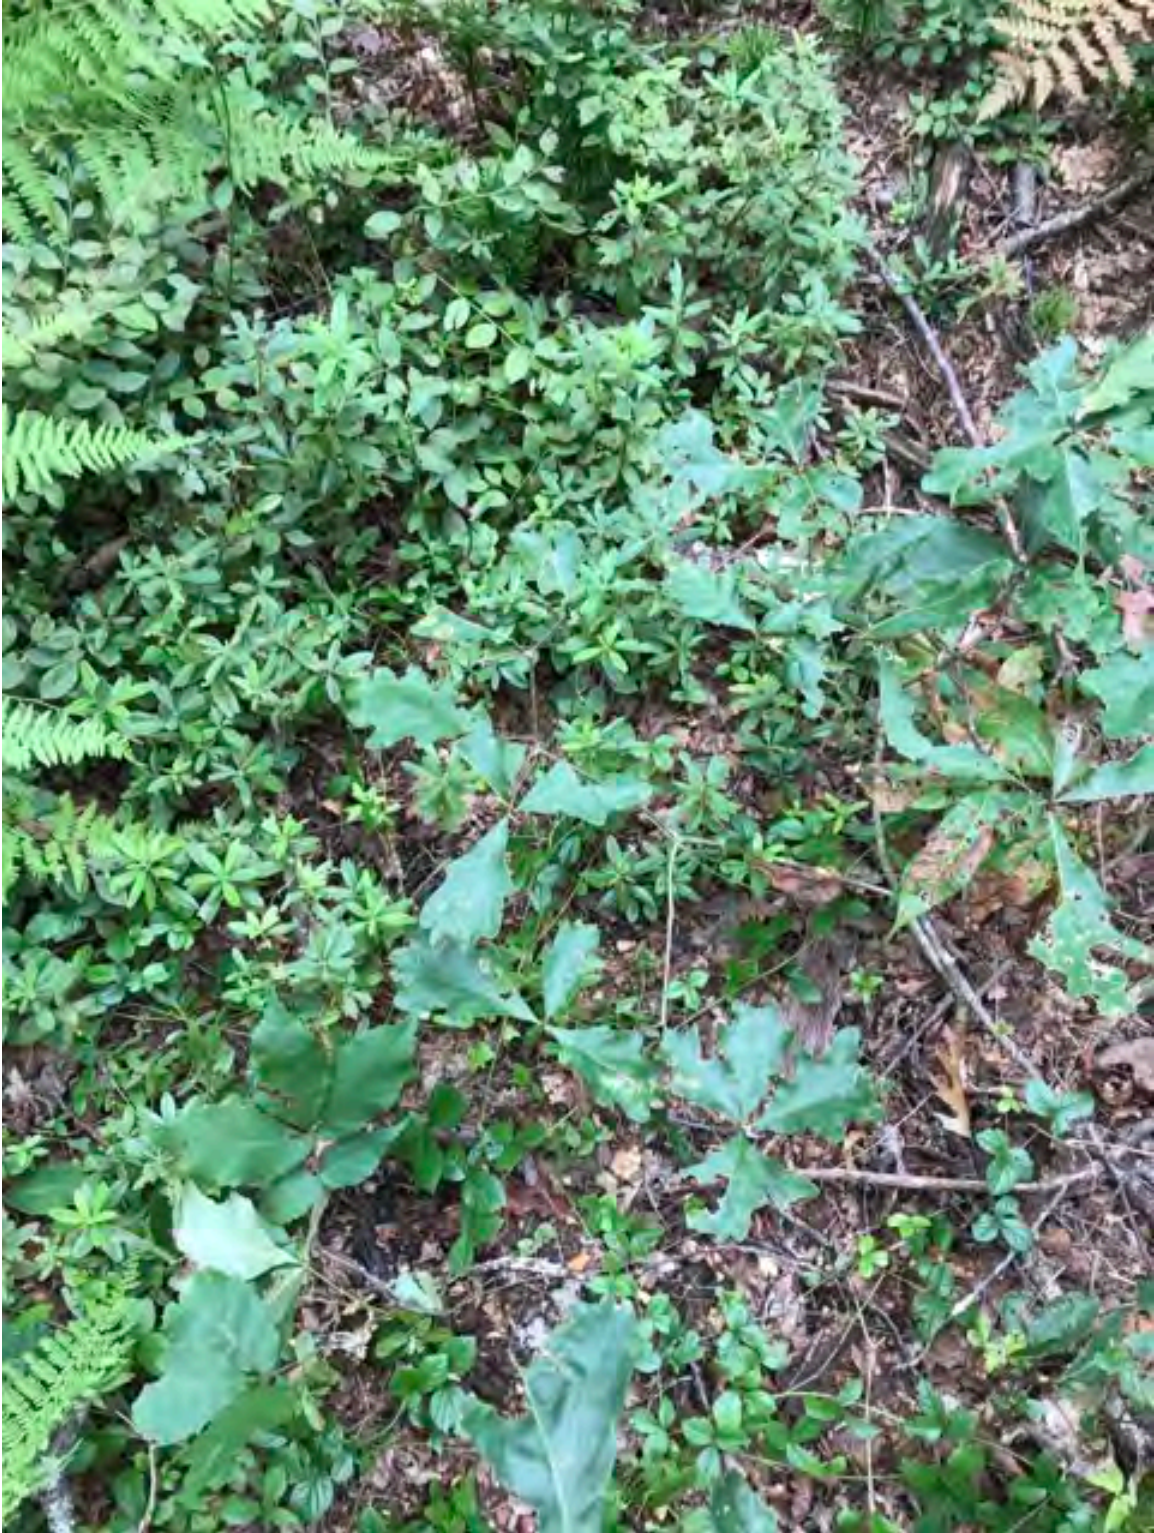
Picture 9: In other areas the understory is in a more neutral (mostly bare leaf litter) or even positive condition, with desirable native plants such as huckleberry and lowbush blueberry (left) (note some hayscented fern) and prickly dewberry, or oak and hickory seedlings (right) that could be released. The presence of these oak seedlings offers a window of opportunity: attempting to release these at a large

enough scale is the best chance of securing these for a future overstory before they succumb to browse, interfering vegetation, and shading.

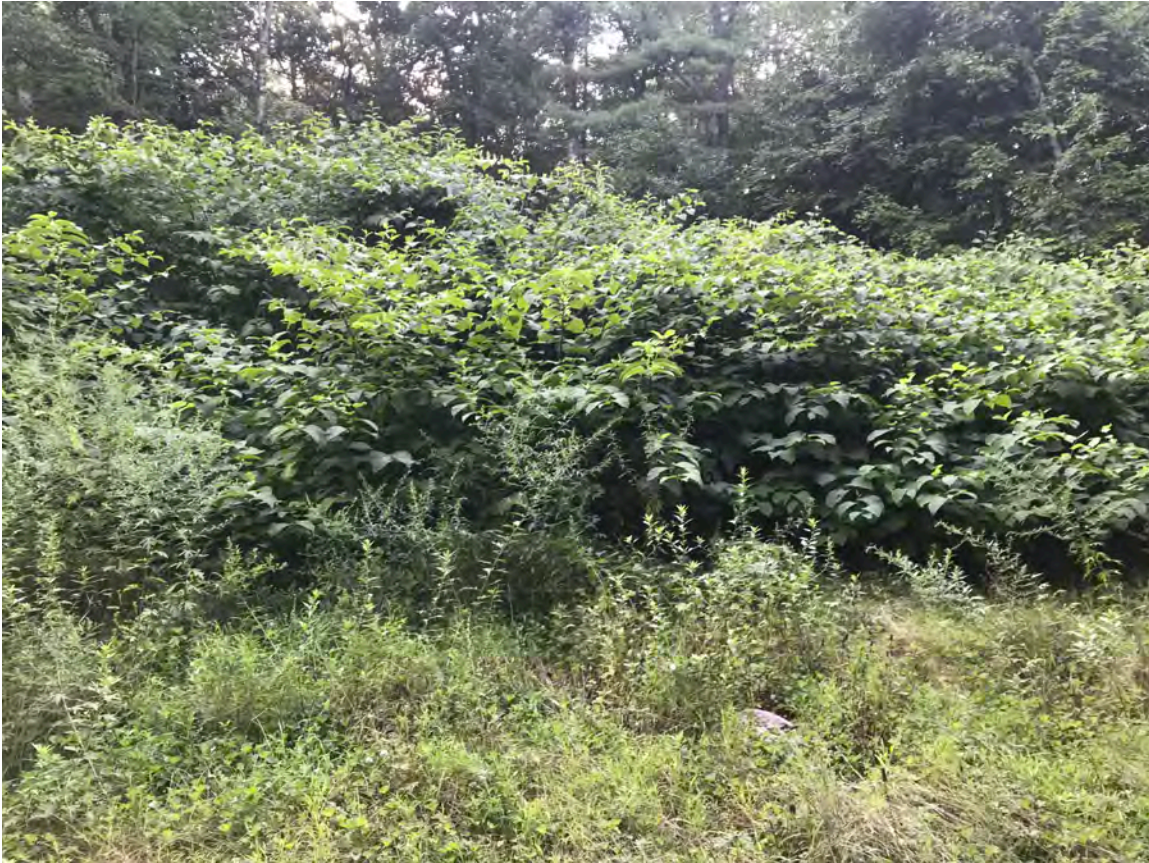
Picture 10: Invasive plants are a serious concern in Ludlow. These non-native plants interfere with the normal functioning of the forest. Fortunately, at the Ludlow site, most of the invasive plants seem to be concentrated along existing roadways (including the paved path), and are not widespread in the woods. The picture above shows Japanese knotweed on the old log landing in the northwest part of the site.

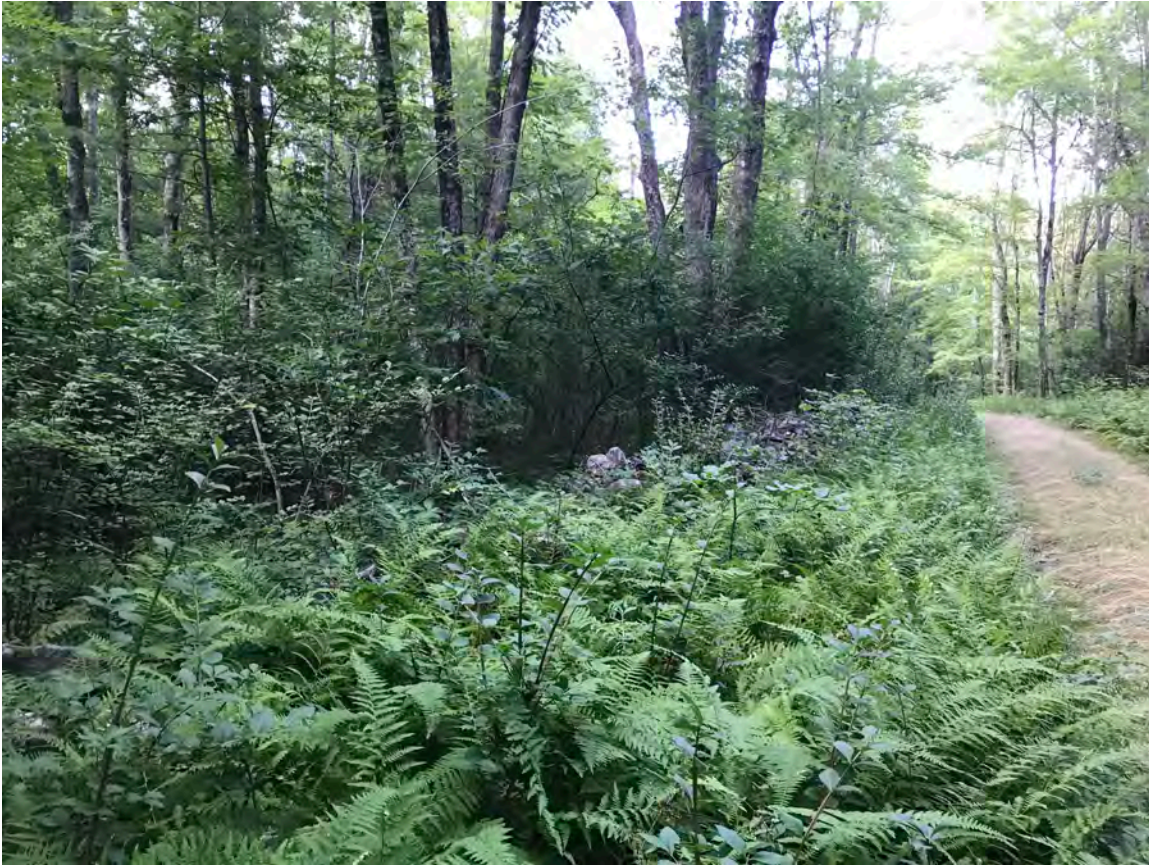
Picture 12: This pic taken along the old truck road to the landing shown in the previous picture shows hayscented fern in the foreground and a thick, dark green midstory of burning bush (winged euonymous), a non-native invasive shrub, underneath the tall trees. It is not readily perceptible, but stems of burning bush are sticking up through the hayscented fern in what is a roadside strip maintained by brush hogging. Without a decisive intervention to eliminate the fern in non-native invasive from a site such as this, an area such as this will not be able to grow trees and effectively will not be functioning as a forest. Other invasives noted include bittersweet, honeysuckle, barberry, autumn olive, and multiflora rose.
