Final Report of Completed Recent Forest Management in Response to the Gypsy Moth at Ludlow Reservoir

Compiled by Michael Mauri, Consulting Forester for the Springfield Water and Sewer Commission, December, 2020

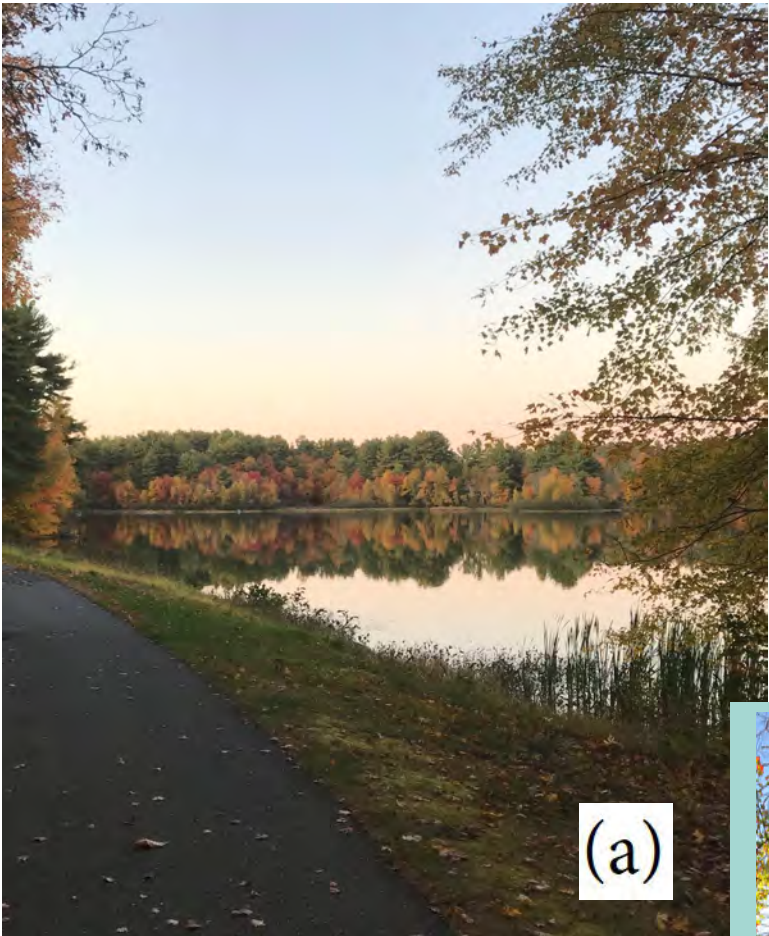
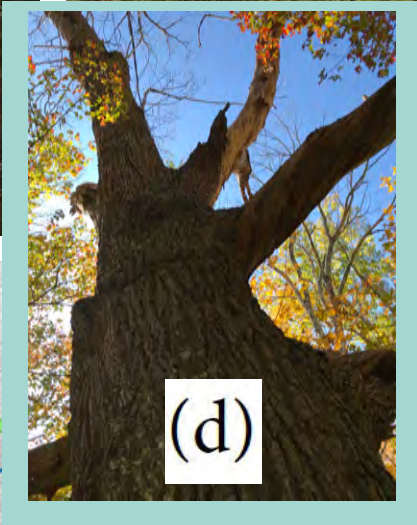
Figure 1-1: Ludlow Forest History

View of the water from the paved walking path around Springfield Reservoir (a). Prior to its construction in the 1870s, the land that is now underwater and much of the forest surrounding it were open farmland. Roughly 14 miles of stone walls such as this one in a recently-thinned pine grove run through the forest (b). A sample of the remarkable network of stone walls is provided by the dashed lines on the adjacent map showing the north end of the reservoir (c). An old oak tree that originally grew in an open field next to a wall (d).

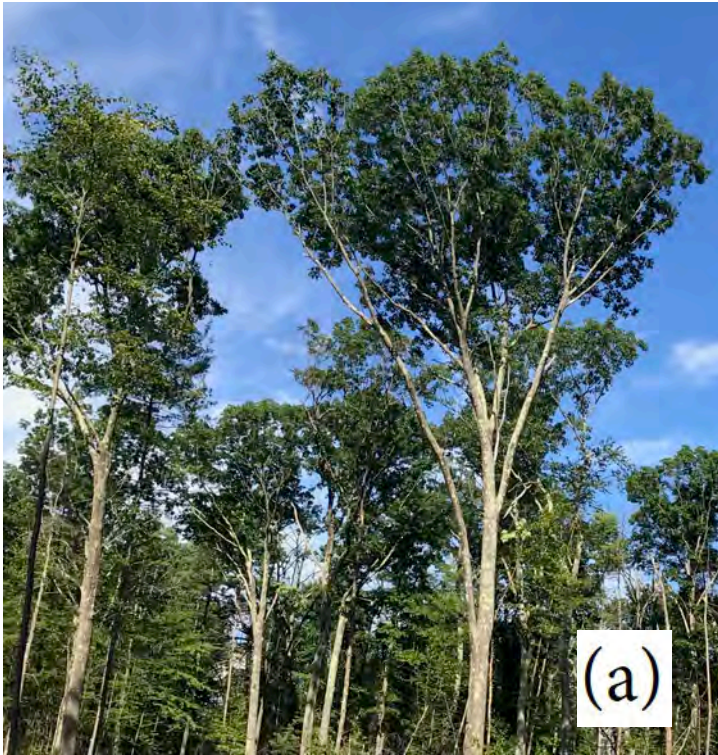
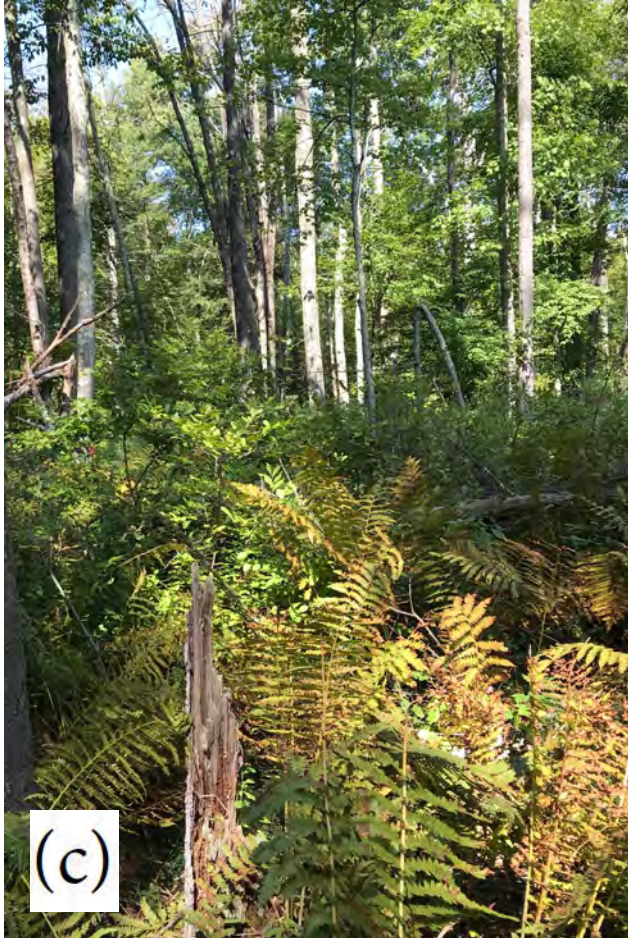
Figure 2-1: Ludlow Core Forest Types

The Ludlow forest contains about 140,000 large trees (trees ≥ 8 " diameter). Of these, about 2/3 are either red oak, white pine or red maple.

Red oak, seen here after a recent thinning, is the single most abundant tree in Ludlow (a). White pines reach great heights (seen here with a hardwood midstory) (b). Red maple is most abundant in the lower slopes and wetter areas, often in a mix with tall ferns and shrubs. The dominant tree species occur in diverse mixes with other trees, including other oaks, sugar maple, birches, ash, hickory and hemlock. These core forest types produce a diverse mix of fruits important to wildlife including acorns, prickly dewberries and winterberries (d).

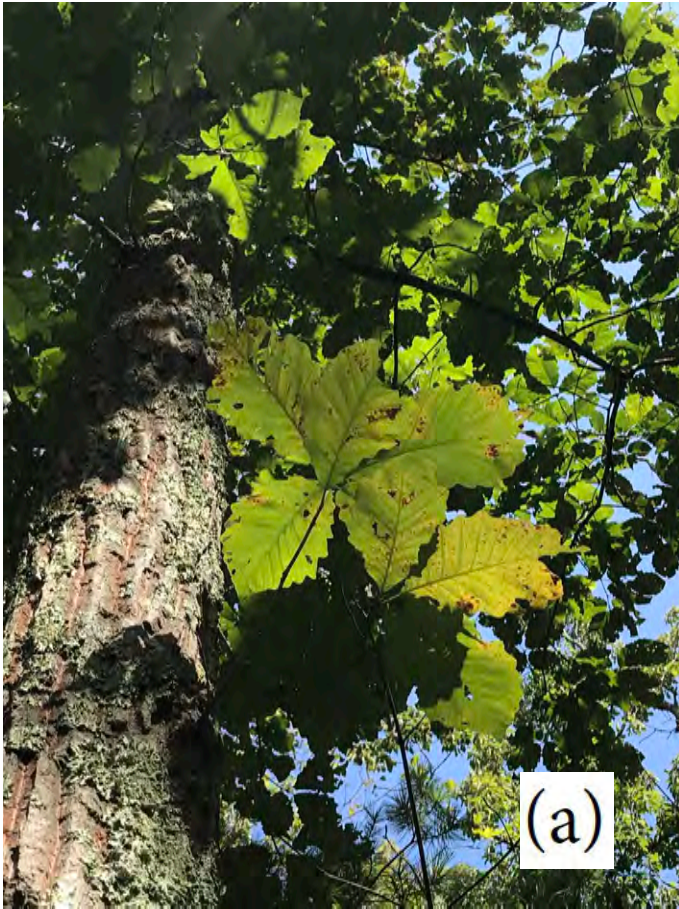
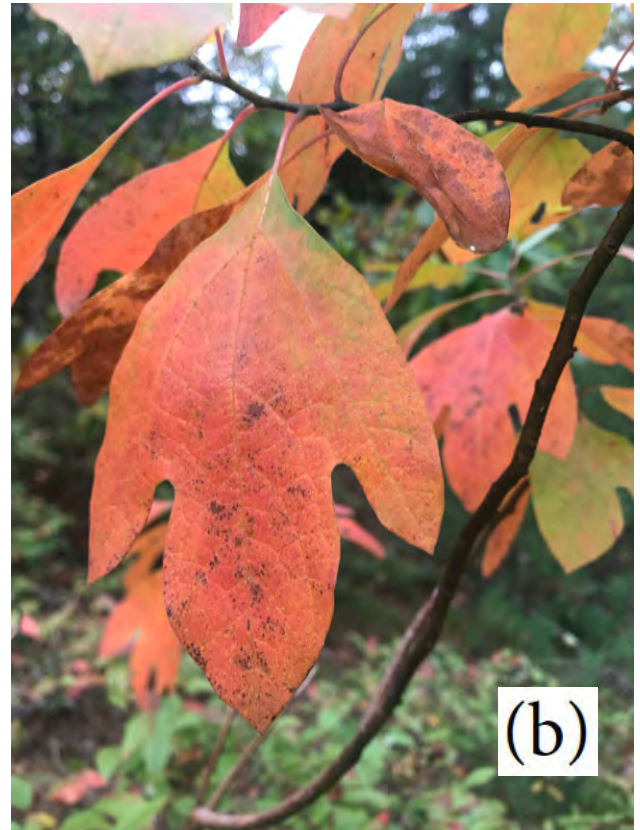
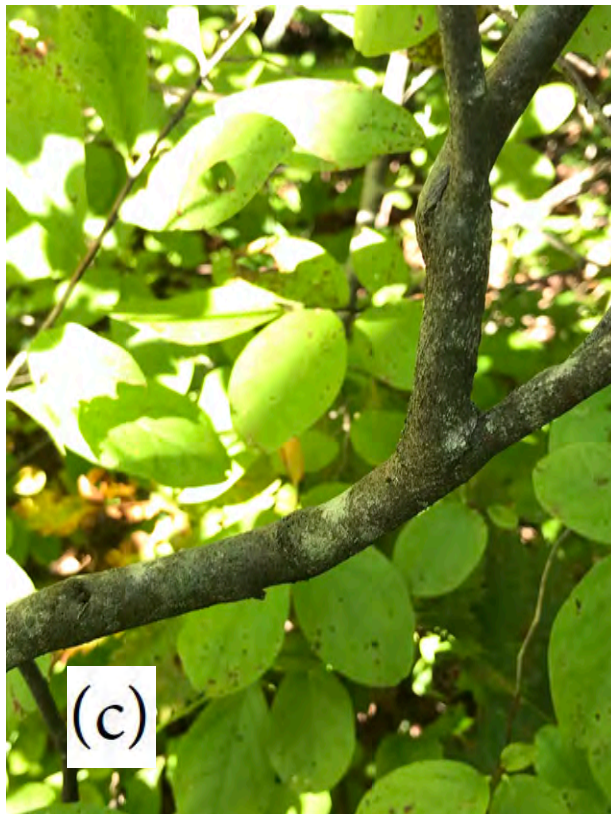
Figure 2-2: Forest Tree and Shrub Diversity

In addition to dominant red oak, there is also scarlet oak, black oak, white oak and, to a very minor extent, chestnut oak such as this one on High Hill (a). There are minor trees and tree-like shrubs including this sassafras (b), as well as ironwood and musclewood. Shrubs in the Ludlow forest include winterberry, spicebush, beaked hazel, maple-leaved viburnum, lowbush- and highbush blueberry, black huckleberry and its taller cousin known as blue huckleberry (c).

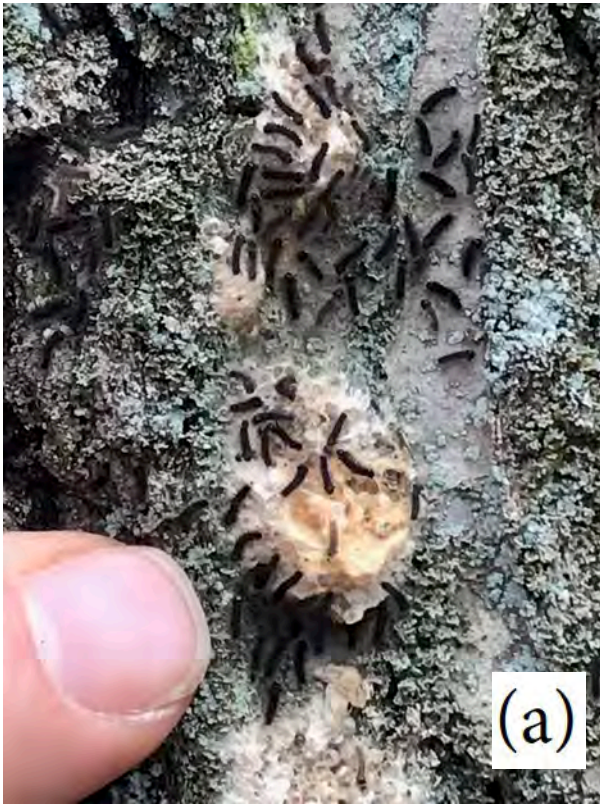
Figure 3-1: Gypsy Moths in Ludlow

Though becoming a moth in its mature life stage, it is as a voracious caterpillar that the gypsy moth defoliates trees. Oaks are a preferred species.

Gypsy moths hatching in Ludlow on May 7, 2019, after overwintering in their light-brown fuzzy egg masses (a). Defoliation begins early on with small caterpillars taking small bites of leaves (b). The caterpillars grow larger and feed more heavily through the early summer (June 21, 2019) (c). By the end of the growing season, oaks, in particular, may have no remaining leaves or may have what appear from the ground to be “shredded” remains of leaves such as this leaf as seen on September 17, 2018, greatly compromising growth (d). The purple line shows an estimate of the original leaf size (e).

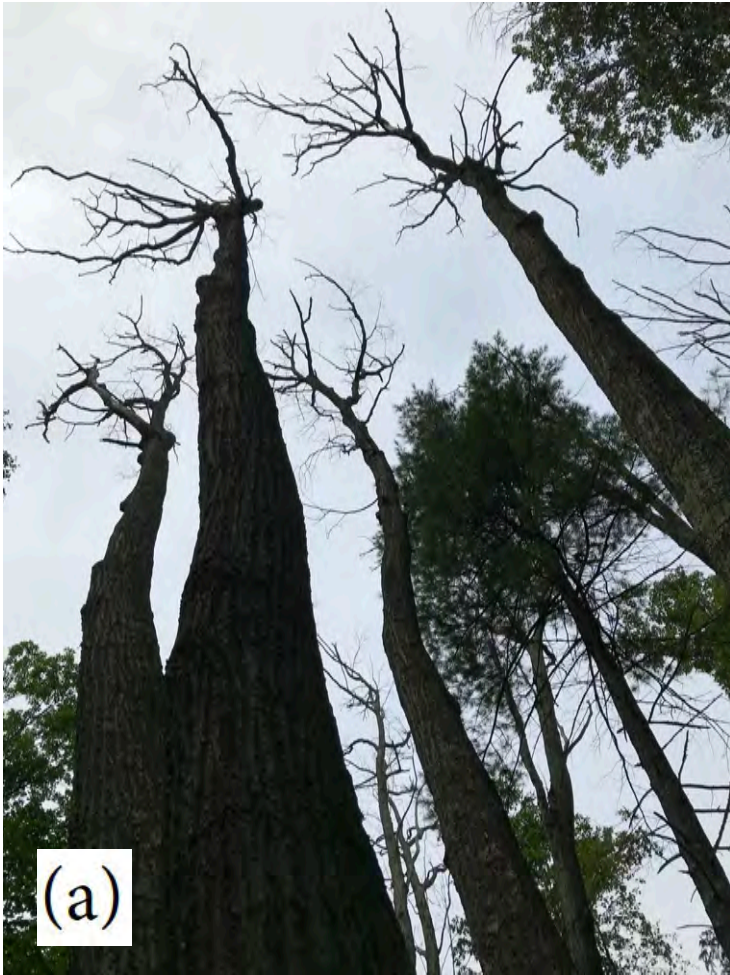
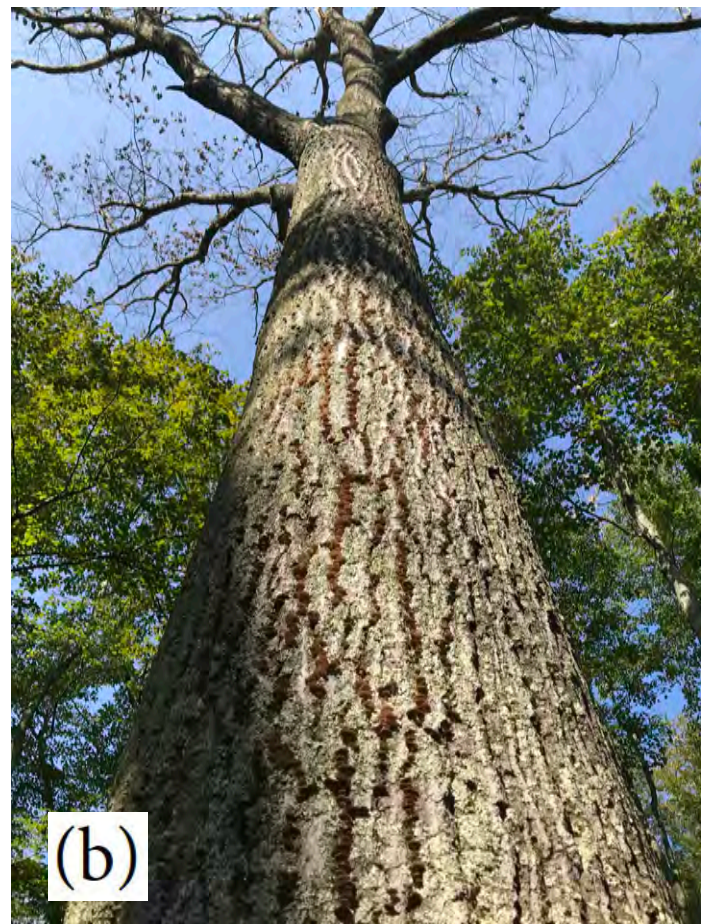
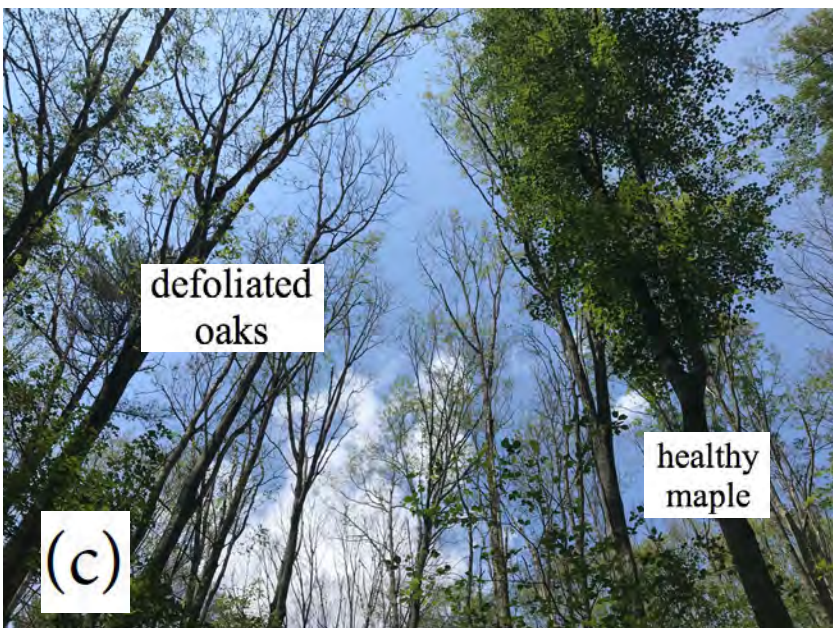
Figure 3-2: Gypsy Moth Impacts in Ludlow

About 1/3 of all large oaks, totaling more than 25,000 trees, were directly or indirectly killed by gypsy moths in the recent outbreak (ca. 2016 – 2019).

Even large, apparently very healthy oaks died as a direct or indirect result of successive defoliations over several years. Large dead oaks seen in September 2020 (a) & (b). Group of large oaks either totally defoliated or with shredded leaves seen on August 8, 2018. A red maple in the foreground shows what a healthy tree normally looks like at this stage of the growing season (c).

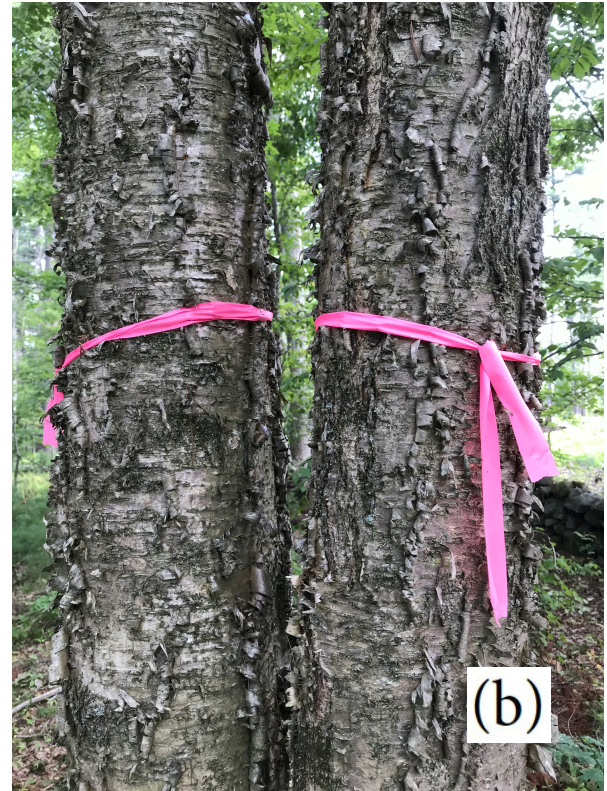
Figure 4-2: Forestry Methods used in Ludlow

A variety of forestry methods were used to direct the logging process and create the conditions for the next stage of forest growth.

Each tree to be cut was marked in blue paint, providing the loggers with a clear set of on-the-ground instructions (a). Pink flagging was hung on selected trees to provide additional clarity about important features to protect, such as these yellow birch stems (b). The area marked for logging was irregular in shape (see green area), following natural patterns that allowed the retention of desirable forest features around the edges, such as large, healthy trees (c). Even within the heaviest areas of cutting, a significant component of the pre-existing forest was retained to provide continuity (Google aerial image showing portion of Ludlow forest post-logging, 9-18-2019).

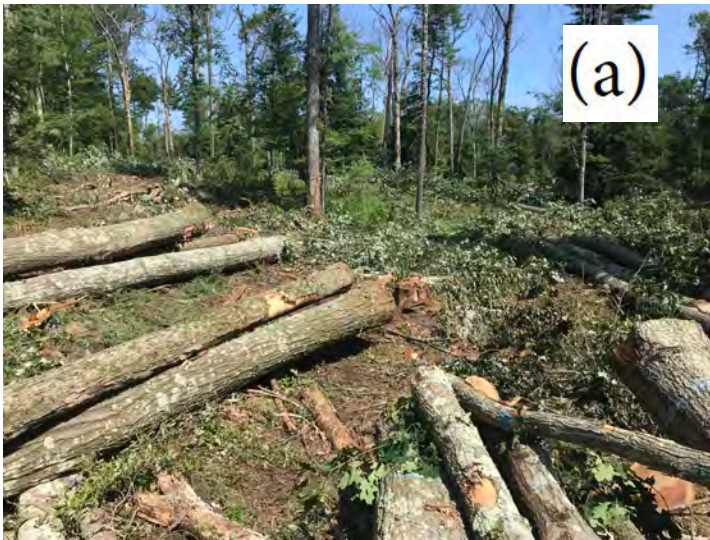
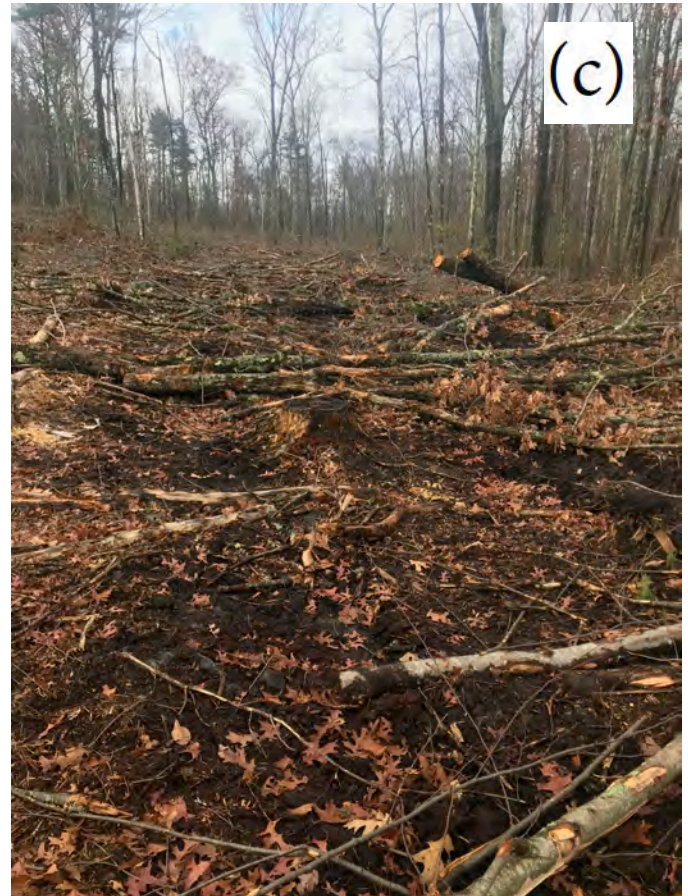
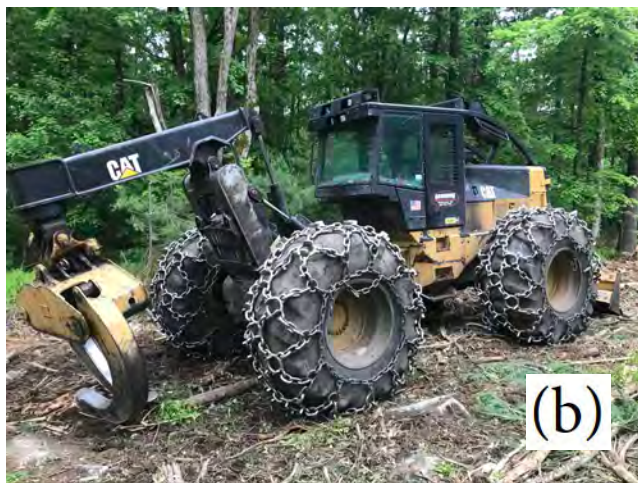
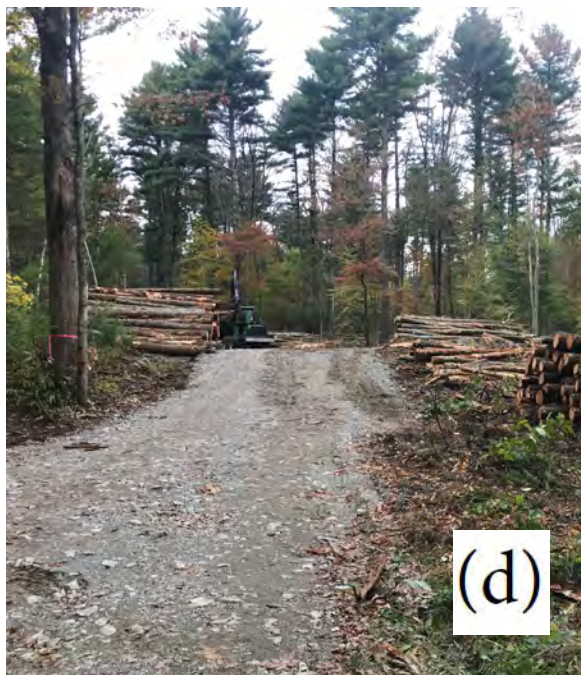
Figure 4-3: Logging in Ludlow 2019-2020

In the multi-step logging process, the loggers cut standing trees that had been previously marked in blue paint by the forester, and then turned them into logs, firewood, pulpwood and in some cases chips.

A number of logging systems were used. Ultimately, all forest products to be sold were taken out to a log landing where they could be loaded onto trucks. Selected pictures show oak stems in the forest ready to be pulled out to the landing (a), a grapple skidder for pulling logs (b), a logging trail (c) and a log landing with log piles on either side (d).

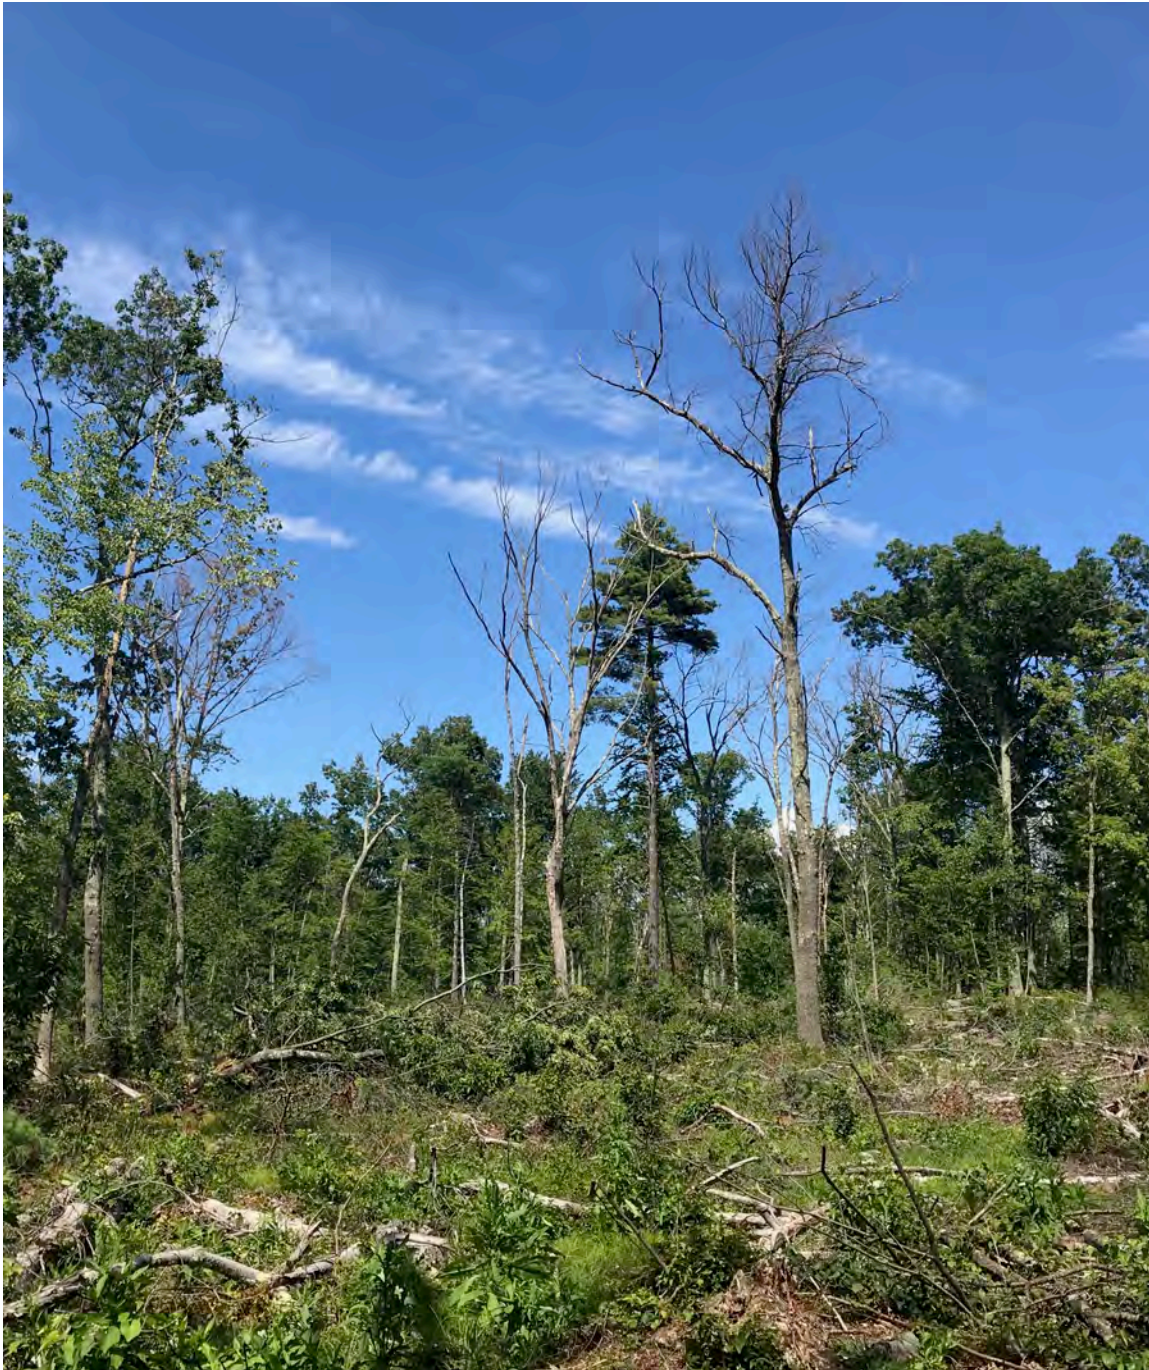
Figure 4-4A: Intriguing Conditions for Young Forest Establishment

Openings were created in designated areas to let in ample light for the establishment and growth of a diverse mix of trees, including oaks, while also retaining a significant component of pre-existing features such as tall trees (both live and dead) and unusable tops from logging (known as “slash”) and shrubs such as lowbush blueberry. Though messy in appearance, this starting point for young forest is ecologically more complex and diverse than if an even greater level of cutting and a lot of “clean up” had occurred.

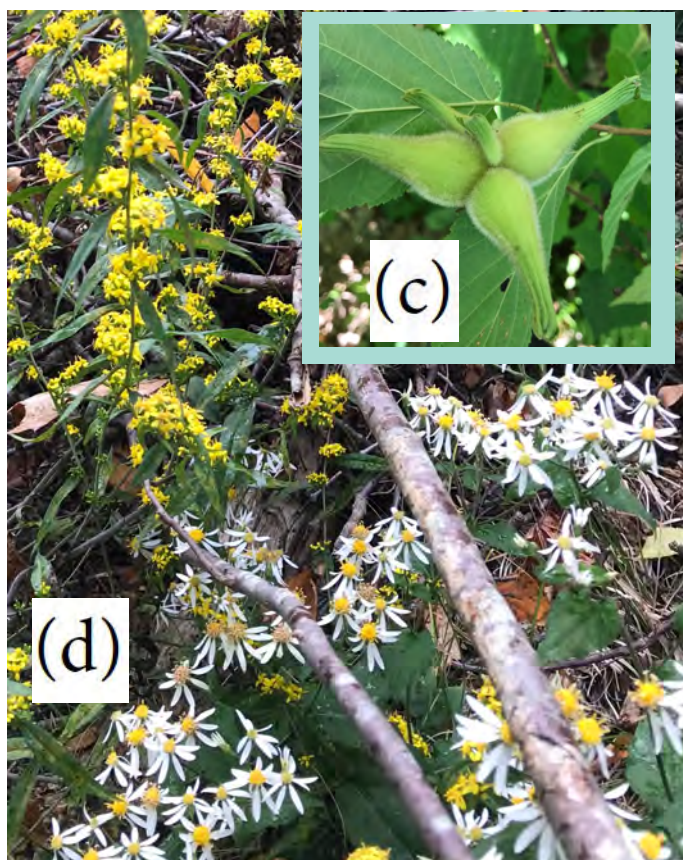
Figure 4-4B: Young Forest Details

Without the shading canopies of tall trees, sunlight can reach the forest floor, stimulating the growth of a wide variety of plants, including a diversity of desirable trees and shrubs.

A top forest management objective in Ludlow is to ensure that a new generation of oak trees can thrive. Though acorns sprout in shaded forest floor environments, the seedlings often do not persist or thrive there due to the shade of taller plants and feeding by deer. This white oak seedling is in nearly full sun and should be able to grow rapidly (a). Full sun increases the abundance, flowering and fruiting of many plants that benefit wildlife such as this lowbush blueberry (b), this nut-bearing beaked hazel (c) or these pollen-rich goldenrods and asters (d).

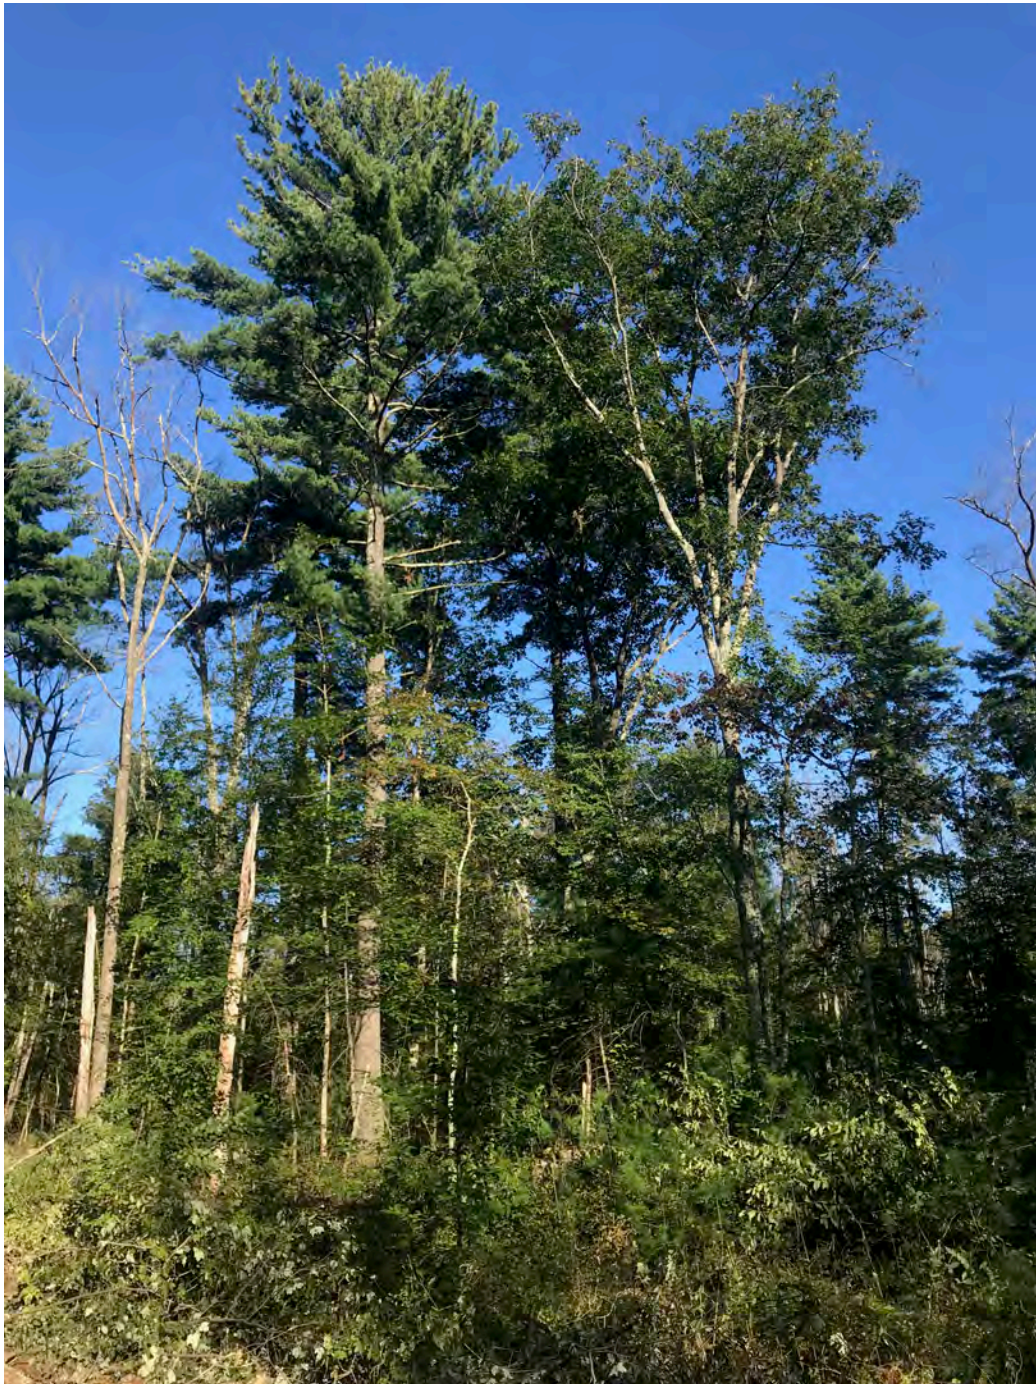
Figure 4-4C: Retention of Complex Structure Within and Near Logged Areas

Shown here: a tall healthy white pine and red oak in a complex, layered canopy including tall dead oaks. A silvicultural approach based on an irregularly-shaped cutting footprint, thinning in pine-dominated sections, and the inclusion of no-cut patches within larger openings allowed for a significant amount of pre-existing forest features to be retained both within and around the logged areas.

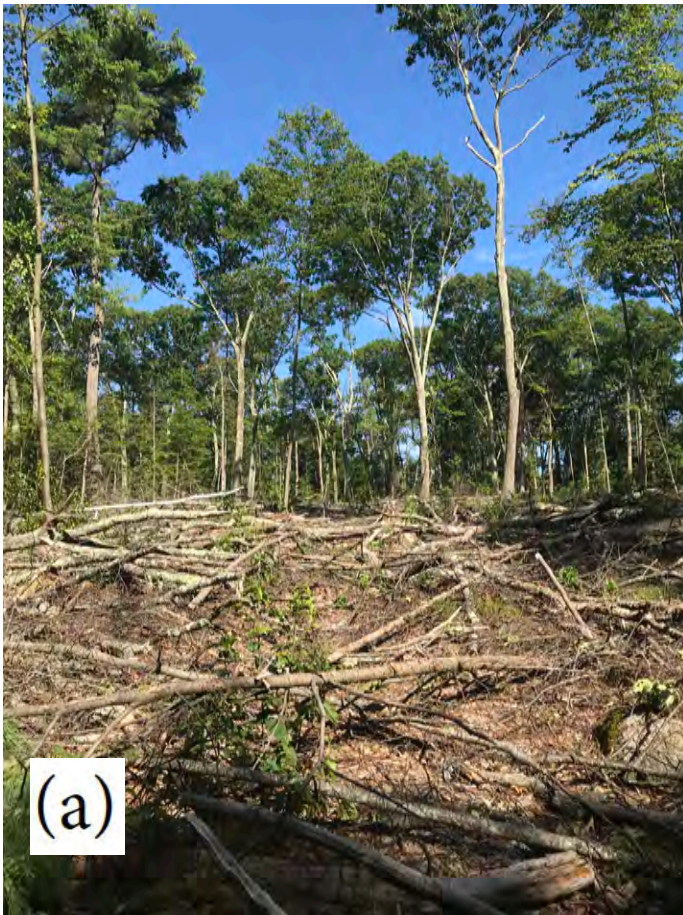
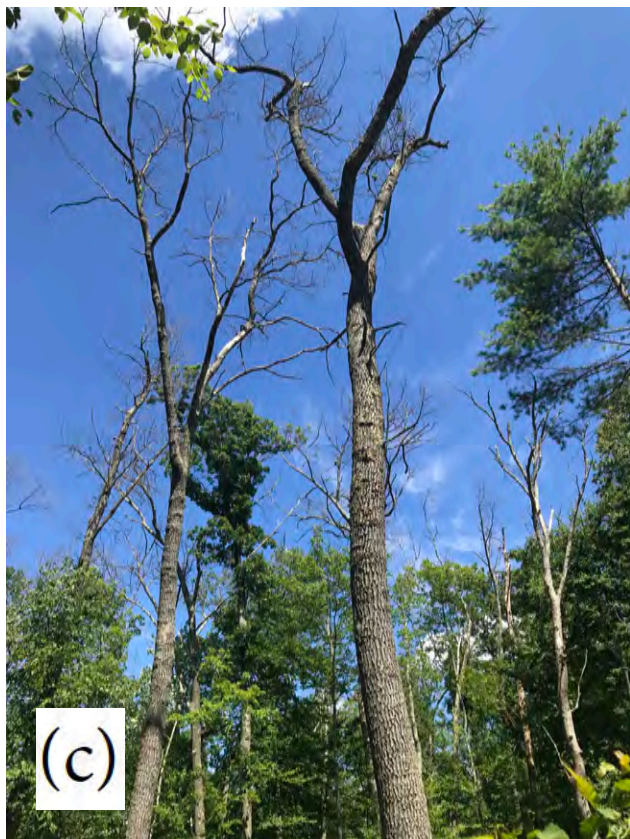
Figure 4-4D: Complex Retention Details

The logging was intended to create conditions for young forest, improve spacing around healthy trees, and improve safety. The intention was not to “clean up” the forest. Within the footprint of the cutting there was significant retention of ecologically beneficial, pre-existing forest components.

Live healthy oak trees in background and tops of logged oak trees in the foreground creating a diverse forest floor environment (a). An uncut patch of diverse, layered forest with both live and dead trees retained within the cutting footprint (b). Standing dead trees or “snags” (in this case oaks) such as those retained within this opening are a favorite of woodpeckers.

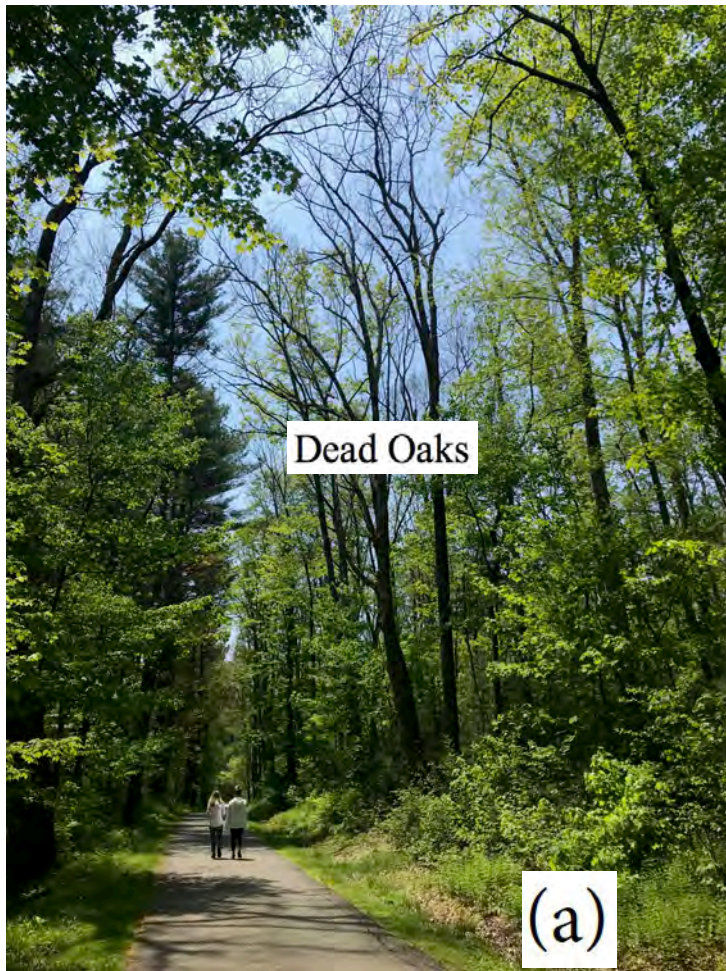
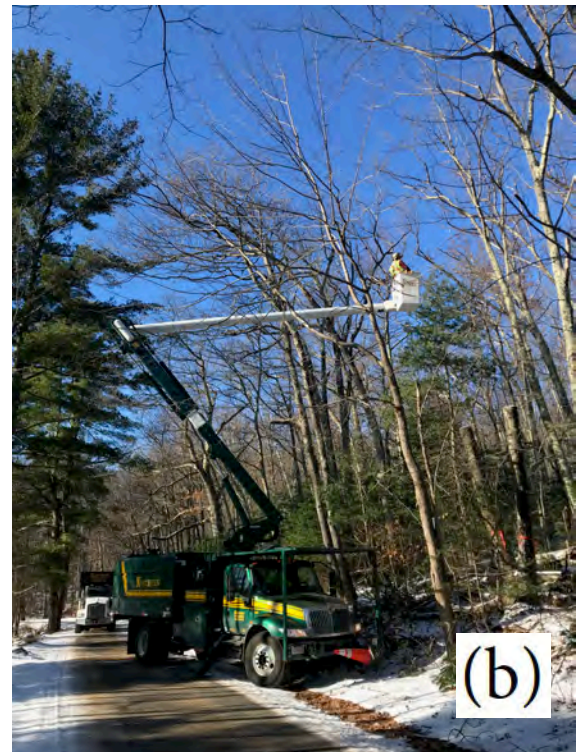
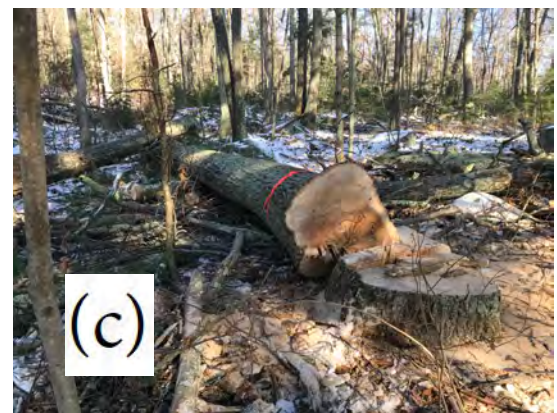
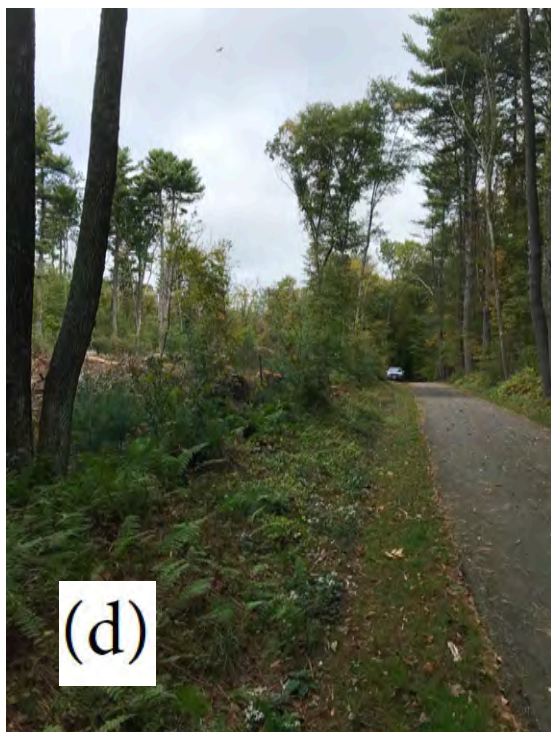
Figure 4-5: Hazard Tree Removal

Dead, rotten and overcrowded trees alongside the path were identified for removal. Most of these were oaks, but there were pines and other species as well.

Prior to cutting, tall, dead oaks like these stretched over the path in May, 2019 (a); a tree service using a bucket truck to remove dead oaks in December, 2019 (b); a dead oak that was cut near the path is no longer a threat (c); many dead oaks were removed from near the path by adjacent logging (d).

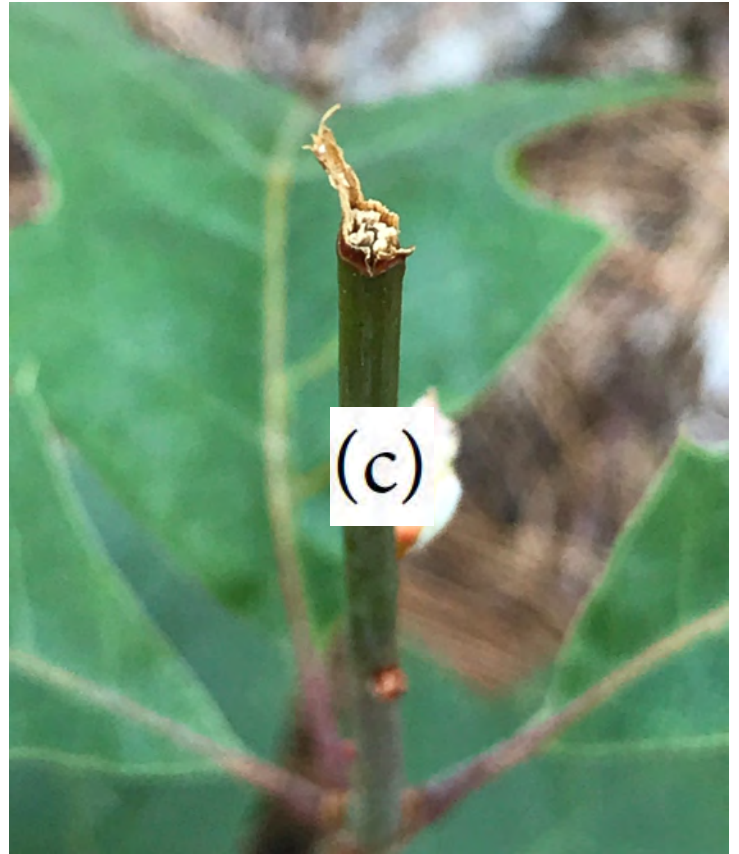
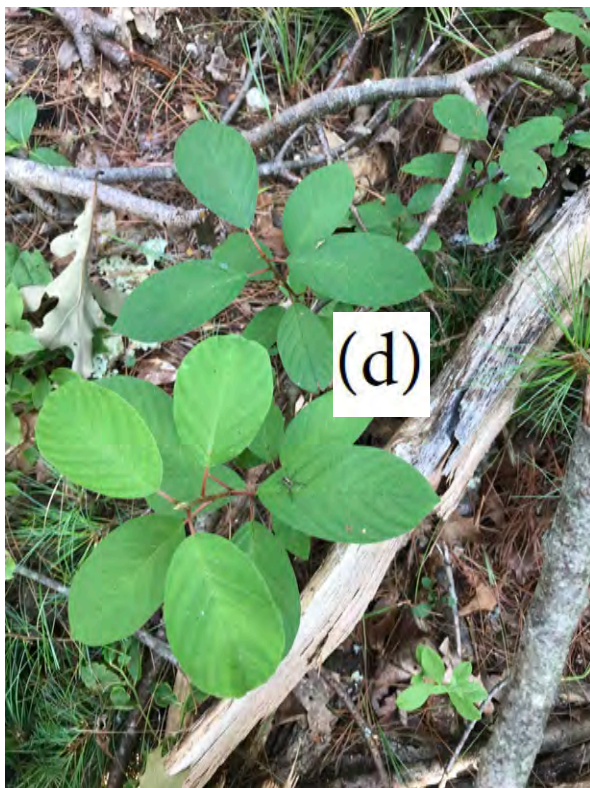
Figure 5-1: Other Impacts on the Forest

In addition to gypsy moths, many other factors are at work shaping the forest; some add beneficial complexity and diversity, while others detract from it. Forest management must deal with all of these factors. A sample is given below.

A large red oak that was bent by the 1938 hurricane, only to be killed by gypsy moths around 2018 (a), and a large white pine that was snapped off by winds in summer 2020 (b) . Main stem of a red oak seedling chewed off by deer – when occurring at excessive levels, the feeding habits of deer have a profound and negative impact on the diversity and growth of the forest (c). Appearing harmless and perhaps attractive, these seedlings of glossy buckthorn belong to a group of non-native invasive plants that can spread quickly, grow prolifically and ultimately outcompete native vegetation (d).

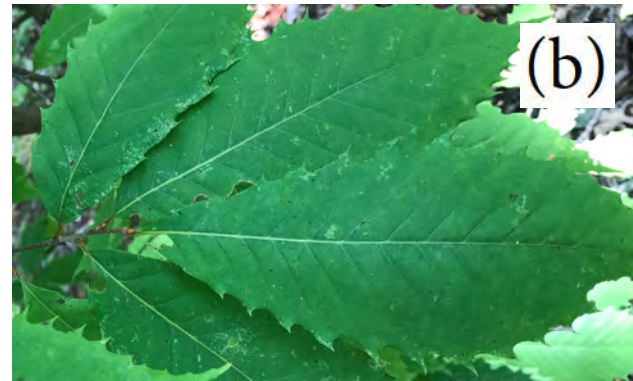
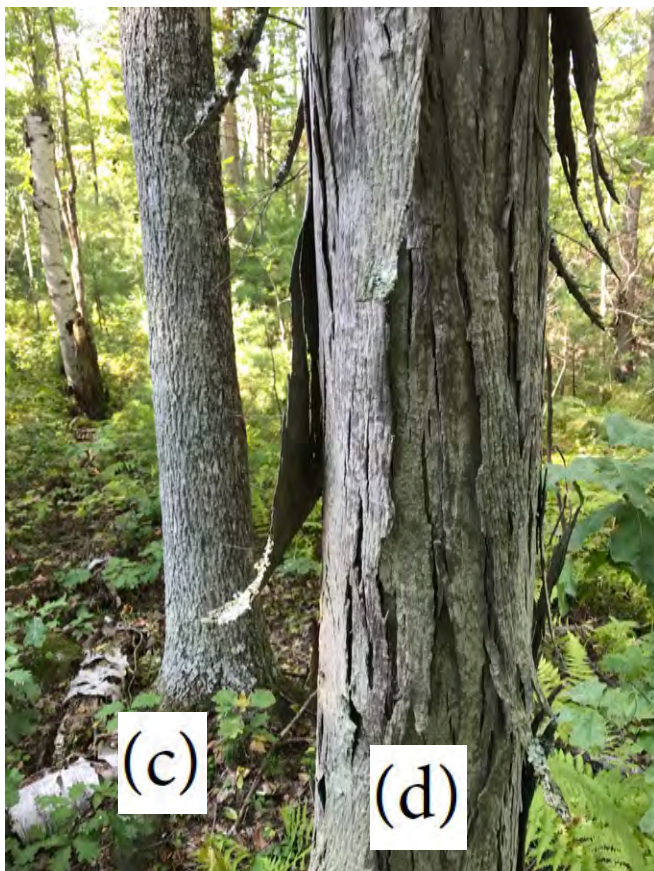
Figure 5-2: Climate Change and Forest Resilience

Forests already face many challenges. If the climate of Southern New England continues to become warmer and wetter, stressful impacts on the forest will likely increase. A forest with its full range of diversity and complexity will be best able to adapt and thereby to protect water quality. Forestry will be called upon to sustain diverse and complex forests and thwart factors that interfere with essential forest capacities.

These dead white pine saplings, once growing vigorously, were impacted by a combination of drought prior to 2018, a recently identified fungal pathogen (*Caliciopsis*) and persistent overstory shade (a). Introduced pests, pathogens, and invasive plants may increase or become more virulent with climate change, intensifying stress on the forest. American chestnut, once an important canopy tree, has been reduced to shrub-like sprouts ever since the chestnut blight, a fungal pathogen, was introduced in the early 20th Century (b). Maintaining a diversity of native trees including those whose natural range extends far to the south of New England, such as these hickories - pignut (c) and shagbark (d) - may help ensure that the forest can adapt to a changing climate.

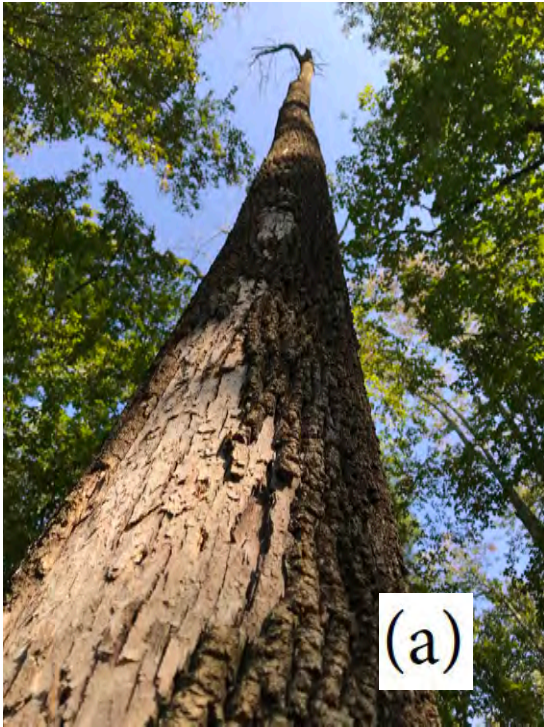
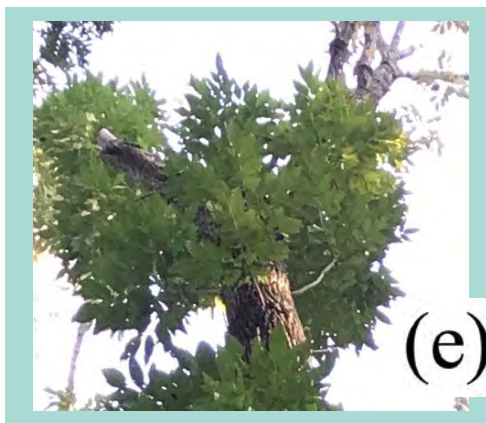
Figure 5-3: Emerald Ash Borer Detected at Springfield Reservoir 9-21-2020

Comprising only about 1% of all overstory trees in the Ludlow forest, white ash is one of a group of less-abundant but nonetheless important species that add diversity and potential adaptive resilience to the forest. Emerald ash borer (EAB) is an invasive insect that has been slowly spreading through Massachusetts and killing ash trees. Unlike oaks in the recent gypsy moth infestation, *most* ash trees are expected to die. The impact - a loss of functional and adaptive capacities that help protect water quality - will be strongest in the wetter areas where most of the larger ash trees occur. And though other species (e.g. red maple, yellow birch) can substitute some of the benefits ash provides, this comes with the risk of greater reliance on this smaller set of species, increasing future vulnerability to other pests or pathogens,

Tall, dead ash tree (a) "blonding" of ash caused by woodpeckers looking for EAB larvae, and D-shaped exit holes made by emerging adults; (b) enlarged view of D-shaped exit hole of an EAB adult; (c) feeding galleries of EAB larvae under the bark; (d) epicormic sprouting by an ash making a last effort to stay alive (e). Note: at the time of the 2018 Ludlow inventory, half of the ash were already dead due to other factors. Due to its low abundance, ash comprised only 6 out of 410 trees 8" in diameter or larger observed in a non-biased systematic sample. All pictures at Ludlow 9-21-2020 by M.M.
